Manhole Inspection Summary

Manhole # S55Q__001MH

Insp Date: **7/29/09 1:16 PM**

Location Address: **1322 WISE CT**

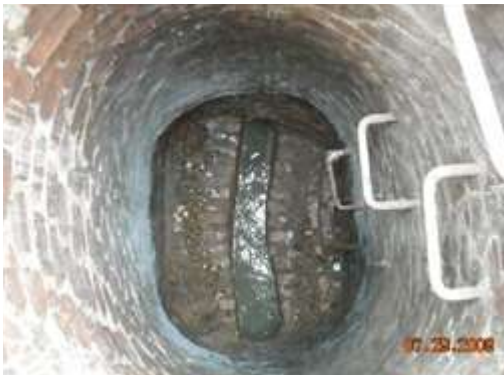
Defect 1

Steps Count: **5** Missing: **1** ☒ **Corroded**

missing/corroded steps

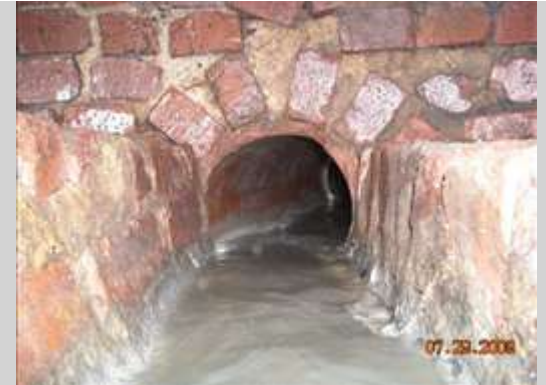
12 O'Clock Outflow

8 in. Circular Gravity Sewer
Pipe Out @ 12 O'Clock

Pipe Height: **8.4** (in.) Rod and Bar (Angled)
Pipe Material: **Clay** ☐ Pipe Lined
Invert Depth: **9.95** (ft.) Flow Characteristics: **Slow**
Deposits: ☒ None ☐ Mud ☐ Sludge ☐ Debris ☐ Grease
Silt Depth: **0** (in.) Deposits Extent:
Infiltration: **None** Pipe Seal Cond: **Sound**

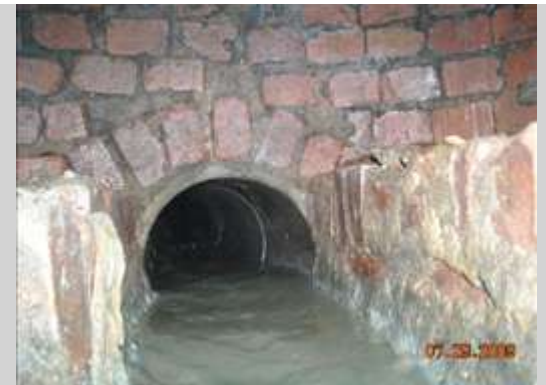
6 O'Clock Inflow

8 in. Circular Gravity Sewer
Pipe In @ 6 O'Clock

Pipe Height: **8.4** (in.) Rod and Bar (Angled)
Pipe Material: **Clay** ☐ Pipe Lined
Invert Depth: **9.80** (ft.) Flow Characteristics: **Slow**
Deposits: ☒ None ☐ Mud ☐ Sludge ☐ Debris ☐ Grease
Silt Depth: **0** (in.) Deposits Extent:
Infiltration: **None** Pipe Seal Cond: **Sound**
